Performance Analysis/Recommendations for Farm PV System

Executive Summary

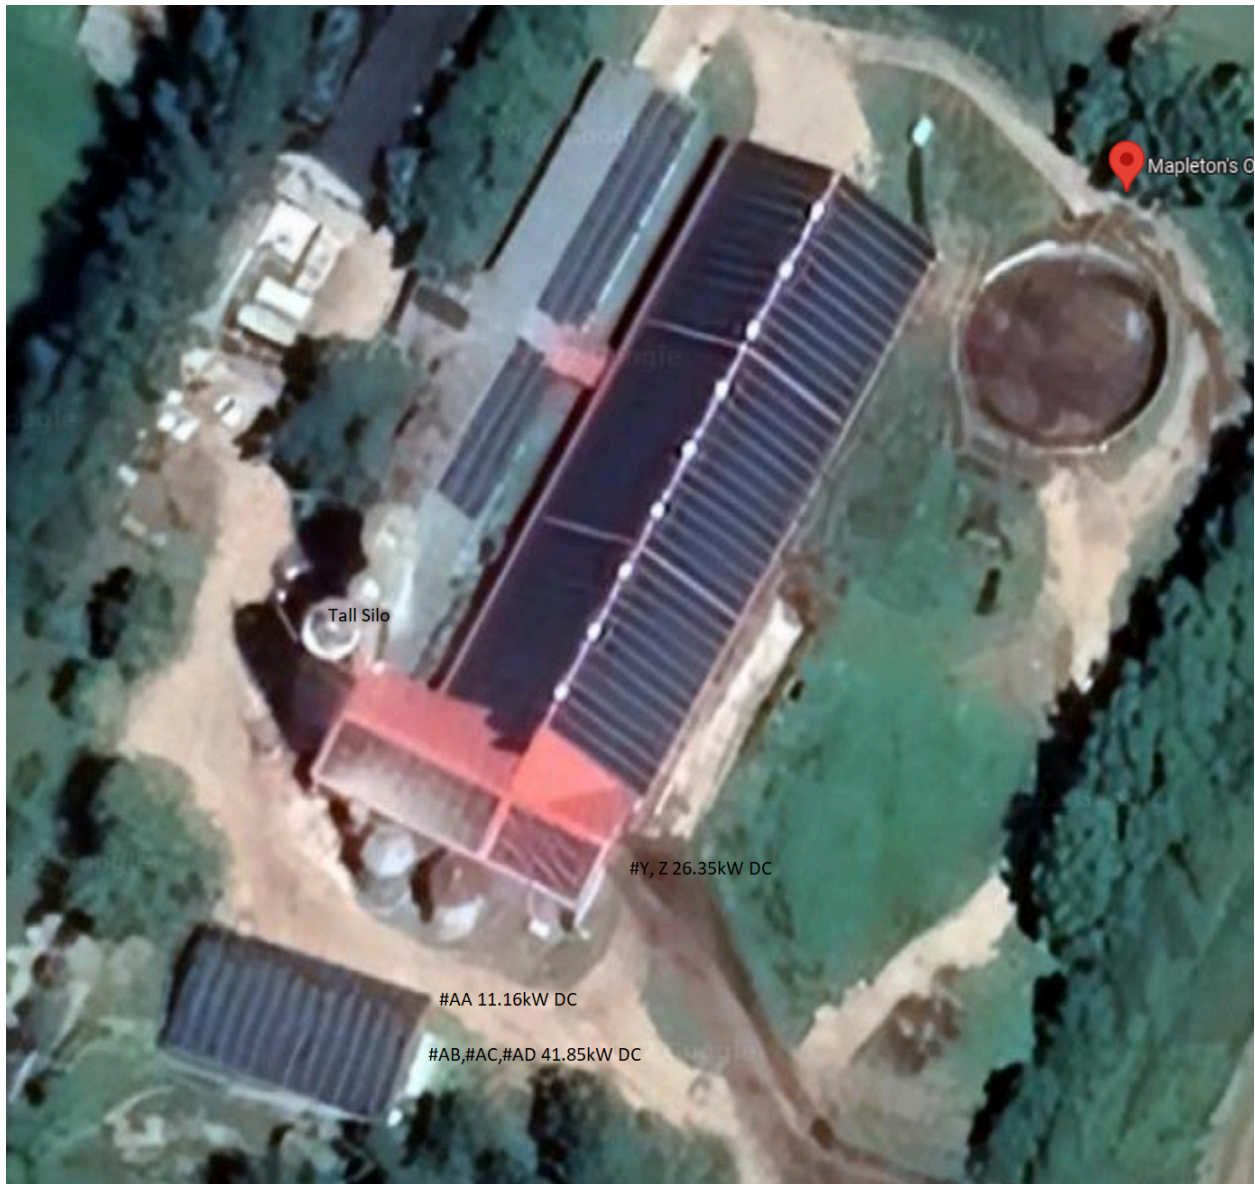
The four inverters we suspect are misconfigured are all on the Driving Shed. The 3 inverters facing south should be the top producers on the site while #AA on the North side would be the worst of the site.

From the image you can see significant soiling present on the #Y,#Z array because of sawdust loading into the barn.

In addition there are significant shading issues from silos both on #Y,#Z but also on some of the Big Barn arrays on the southern end of the barn in the afternoon.

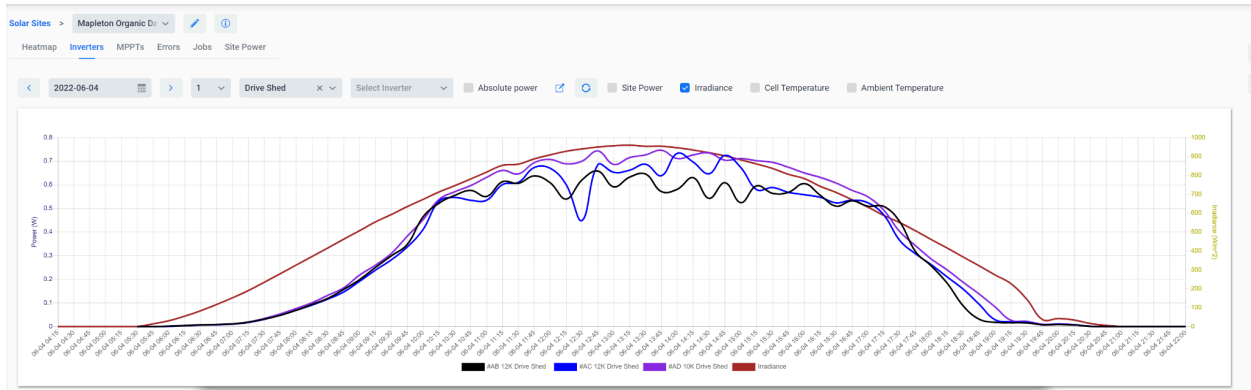
The graph below shows the 3 SW inverters on the Driving Shed. Here you see a very different pattern with all kinds of unexplained drops and also not a clean rounded curve. So the question is why is this happening?

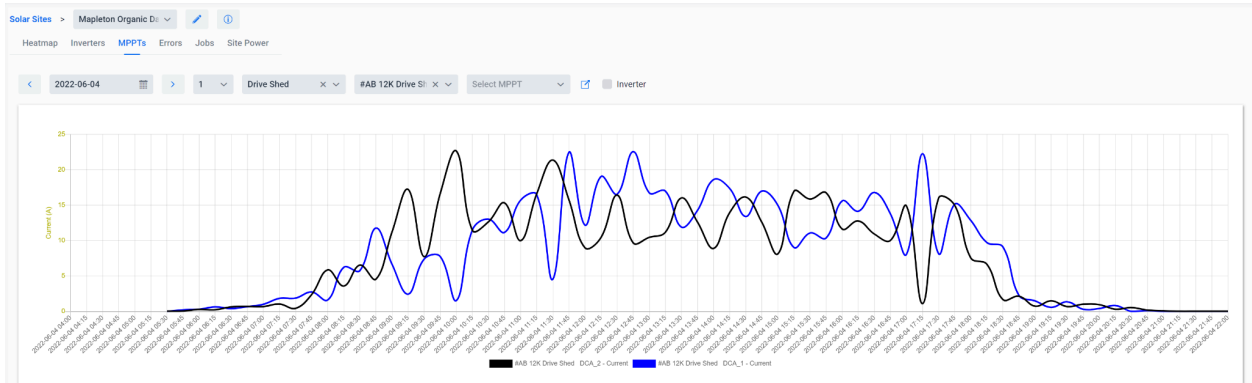
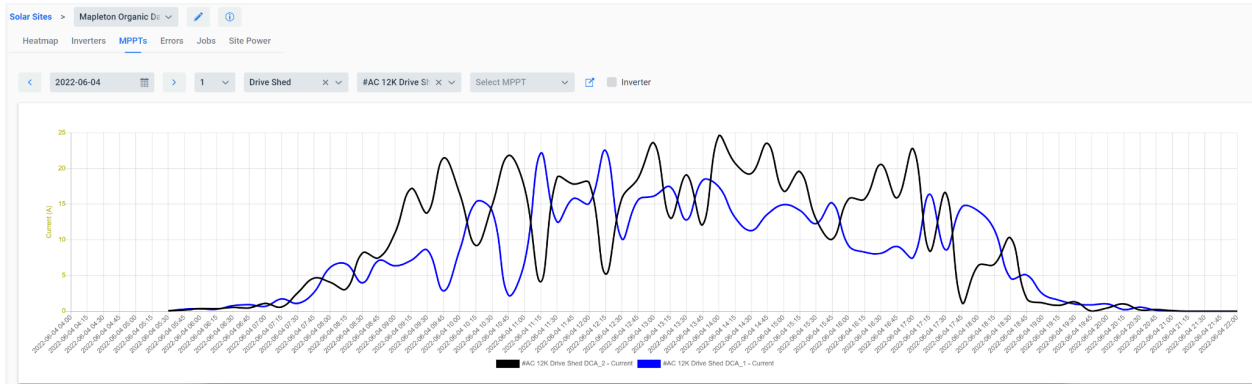
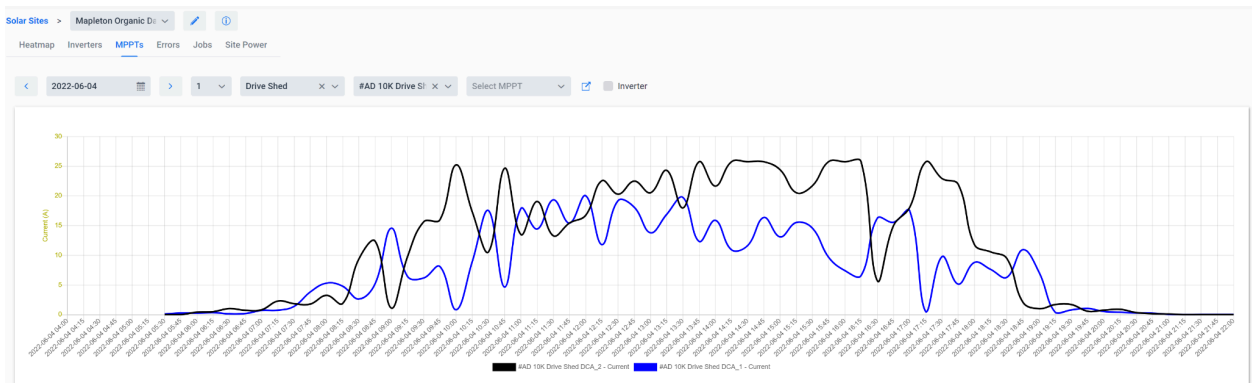
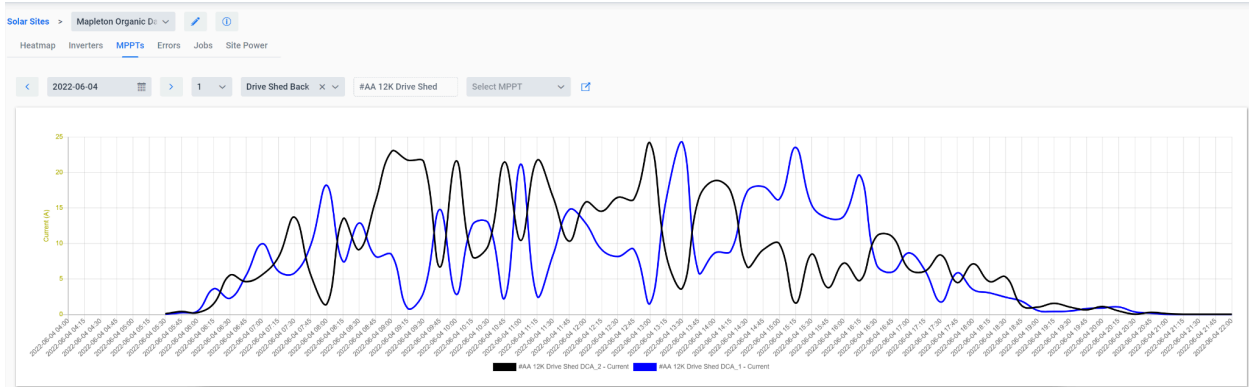
Now shown below are the patterns for the 4 Driving Shed inverters

A major loss which appears to be easily addressable involves a likely misconfiguration of inverters #AA, #AB, #AC, #AD all located on the Driving Shed. All inverters with the exception of #S which is a split between two combiners and roof surfaces should be configured for parallel not independent MPPT operation. However, all 4 of these inverters current profiles indicate that they are likely configured as independent. These problems seem to date back to installation. Since none of these inverters have been replaced we think this explains both their longevity and also why the problem was never detected by an electrician.

The graphs seem to show that the MPPTs are “fighting” with each other rather than trying to optimize the production. What isn’t clear is what is potentially misconfigured. Shown on the next page are the instructions for proper configuration of the inverter which we can then validate on November 10th or could be validated in advance if desired.

- Place INMODE S1 switch UP in the PAR position.
- On the inverter connection board, parallel the two MPPT inputs by means of terminal [-IN1 and -IN2] and [+IN1 and +IN2] using two 10 AWG jumper wires (1 black and 1 red cable) to connect the input as shown below.

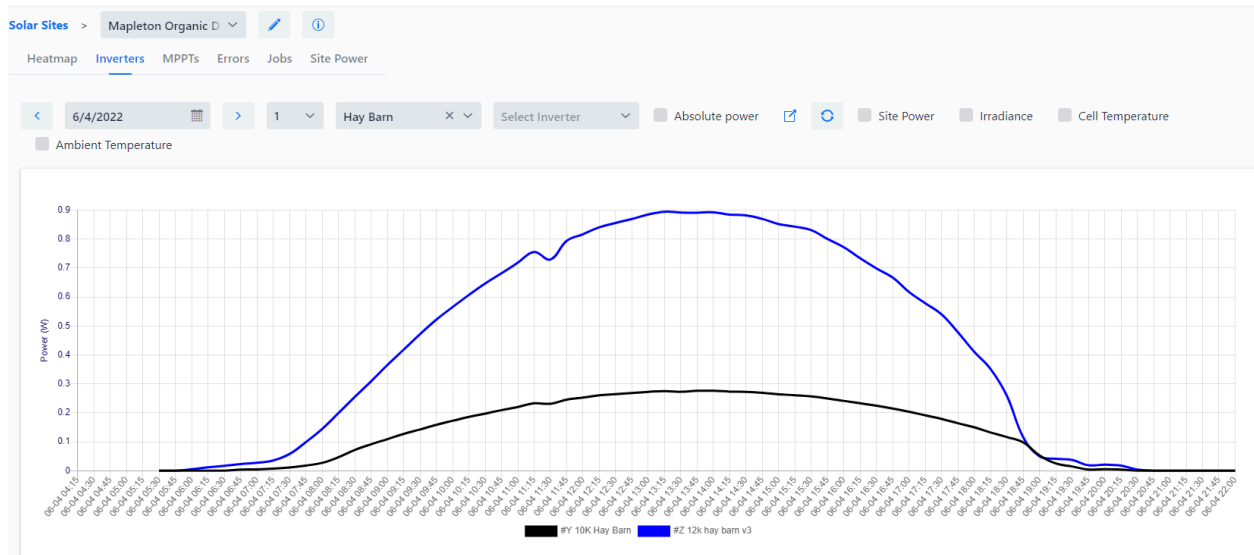
The following inverter graphs are for the Hay Barn on that same day. These graphs are normalized for DC sizing of the inverters. On this particular day Inverter #Y is performing at 31% of Inverter #Z. This could be due to either string(s) failure or significant soiling or a combination of both.

To estimate the current losses on #Y we looked at the total annual output in 2018 for those 2 inverters which was a year with full production because Inverter #Z has been replaced several times. We then contrasted it with the production in 2022.

Assuming the production of #Y can be restored whether through fixing strings or better soiling management the result would represent \$3,200 in 2022.
