Performance Analysis/Recommendations for Farm PV System

Executive Summary

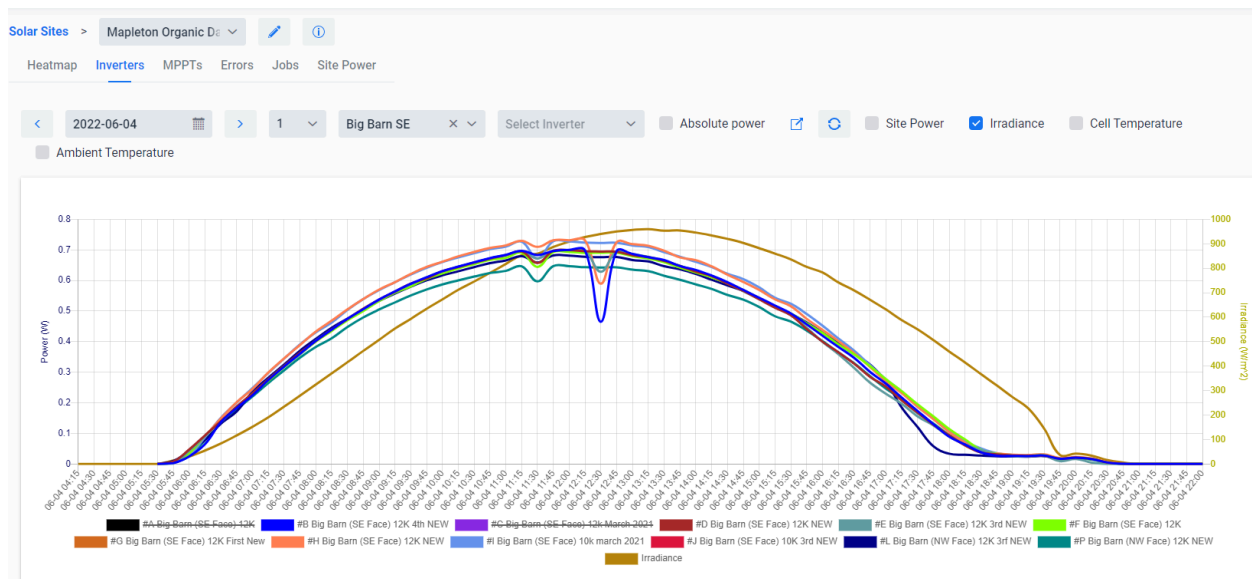
The graphs below are for June 4, 2022 which was a bright sunny day with almost no clouds. The inverter graphs below are for the Big Barn SE inverters which have minimal shade issues and also include data from the irradiance sensor. There appears to be a slight cloud before noon and then the dips you see are due to the tall silo on some inverters.

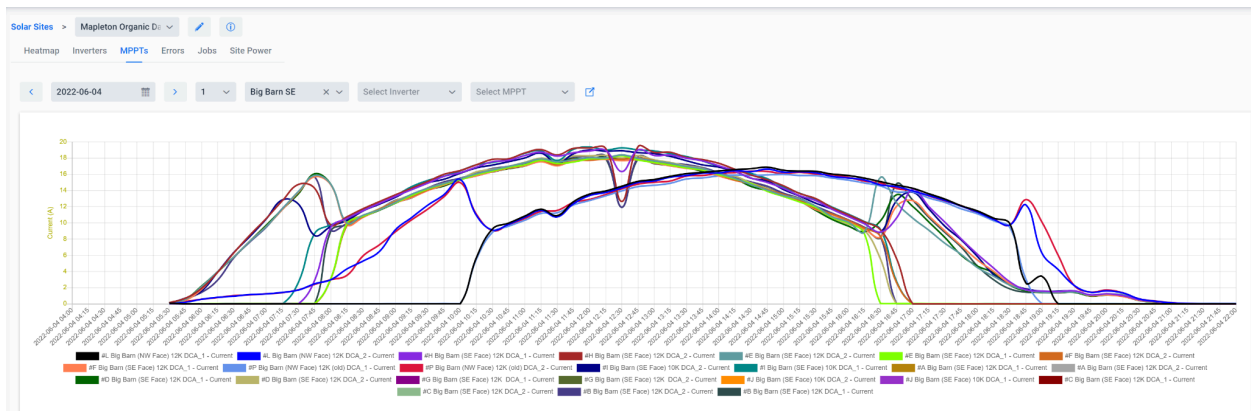
Here for the same day is the MPPT current profiles for the SE Big Barn inverters. The pattern that we see is that when the inverter is set to parallel mode that one or the other MPPT operates until a certain power level is reached. After that the inverter then distributes the current between the two MPPTs. That's why you see increasing current to a point in the morning and then a current drop. The reverse happens in the afternoon. Shading of course and DC sizing impacts when this threshold is reached. This pattern is consistent across all inverters with the exception of #S because it has two roof surfaces and independent MPPTs.

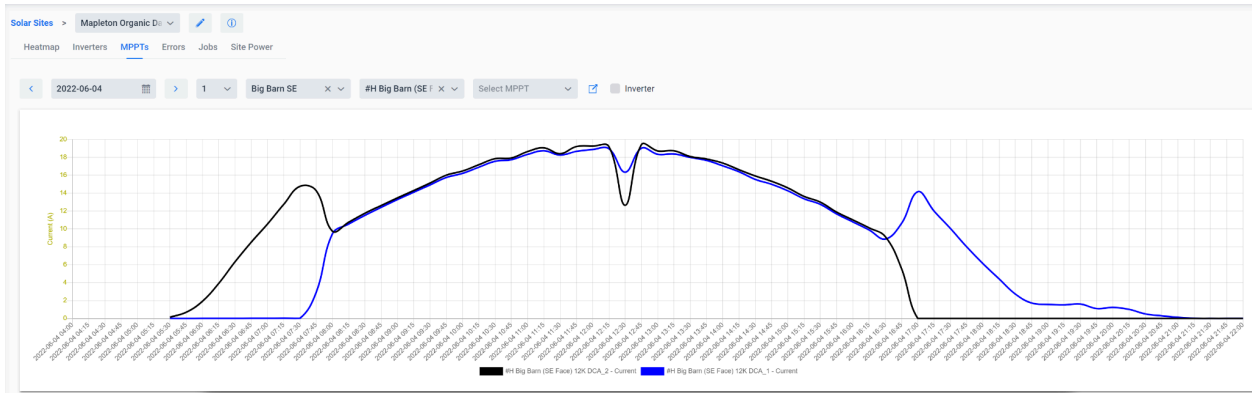
However all the Driving Shed inverters have a very different pattern on that particular day. The first graph shown below is Inverter #H from the Big Barn so you can more clearly see the described pattern and what the curve should look like:
